SITE-SCALE RESTORATION PLANNING ON THE LOWER VIRGIN RIVER, NEVADA

MORMON MESA CASE STUDY

CLARK COUNTY VIRGIN RIVER RESERVE UNIT 1

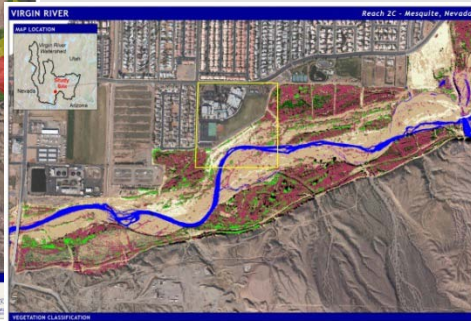
Vegetation Types
(% native vs tamarisk)

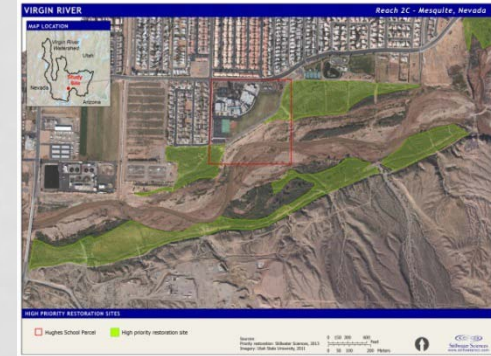
Phase 1: Potential
Restoration Areas

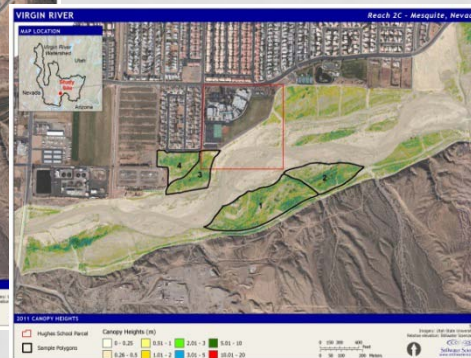
Vegetation Structure

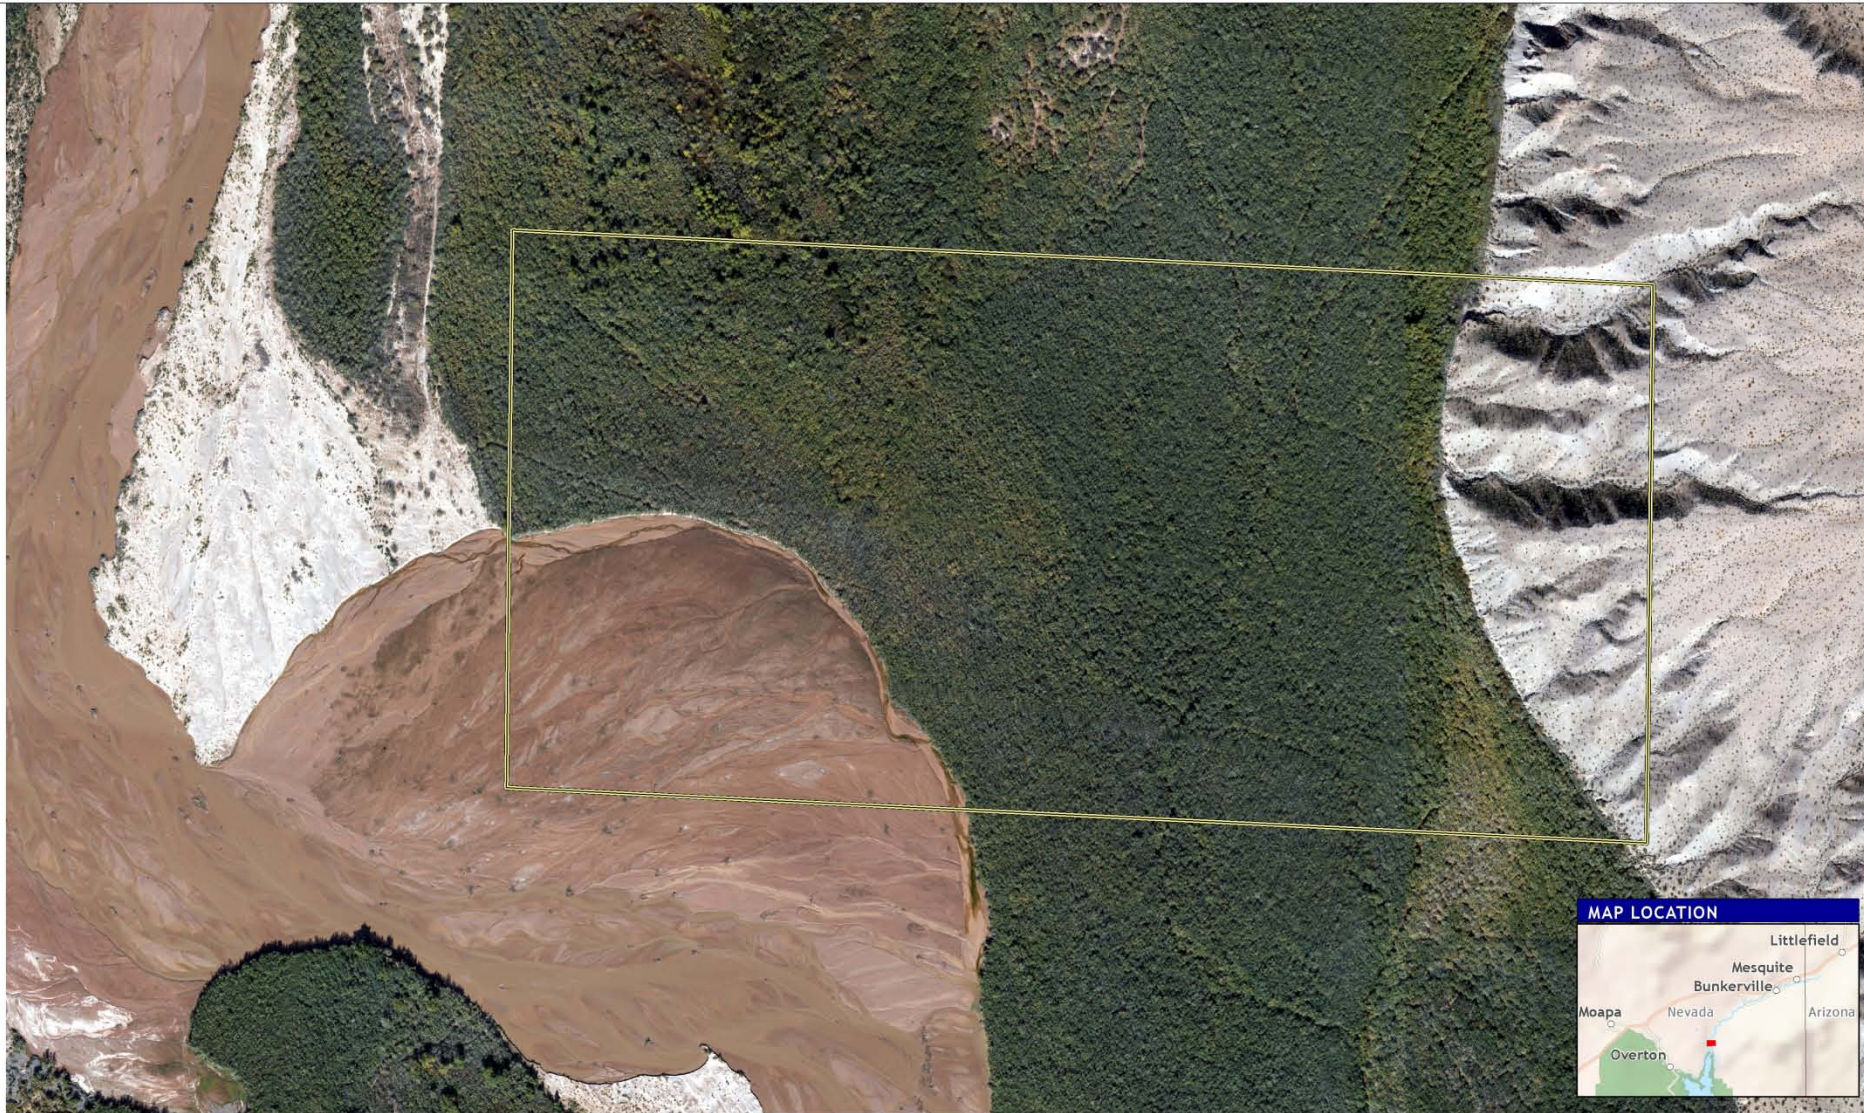
MAP 2. MORMON MESA, VIRGIN RIVER: NOVEMBER 2011 COLOR IMAGERY

EXISTING CONDITIONS

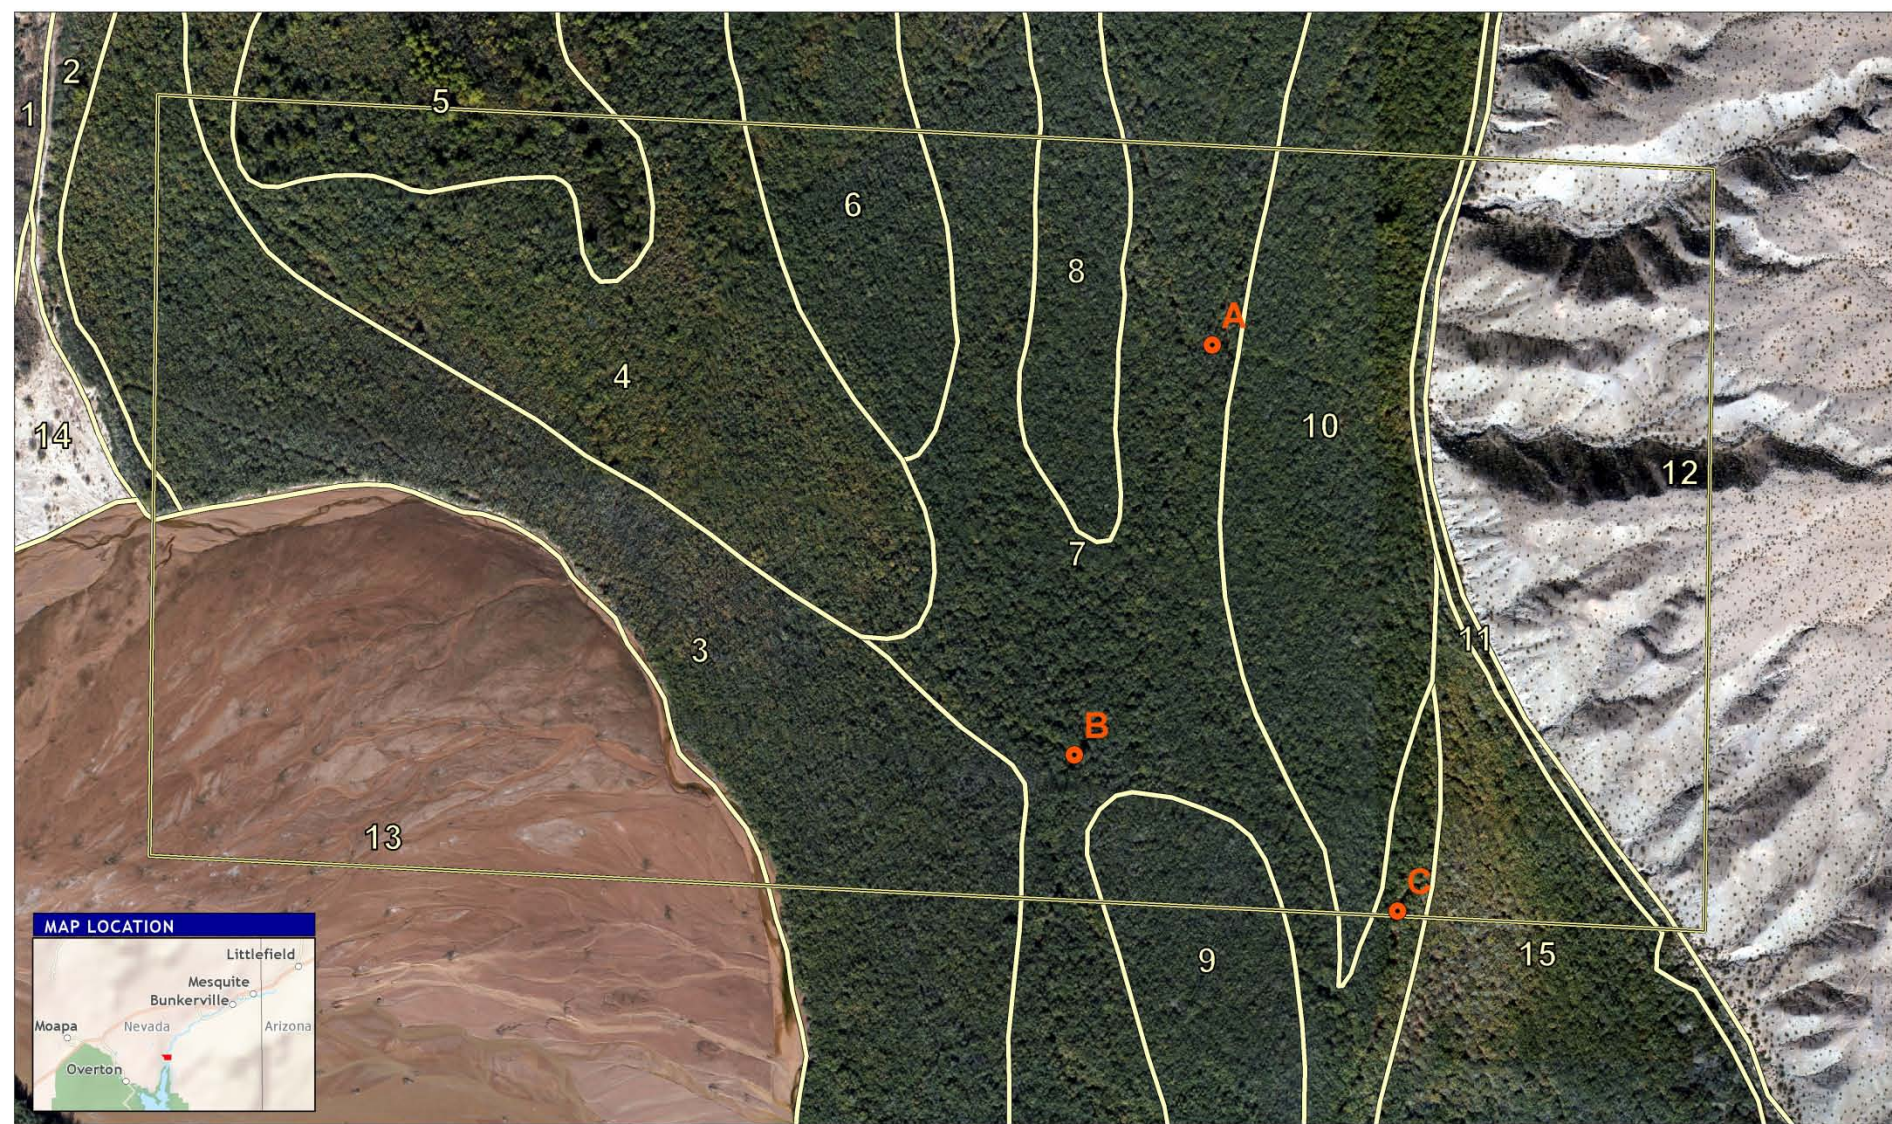
MAP 5. MORMON MESA, VIRGIN RIVER: VEGETATION MANAGEMENT UNITS

- Wet Side Channels Observed
- Vegetation Management Units
- CountyParcel_Boundary

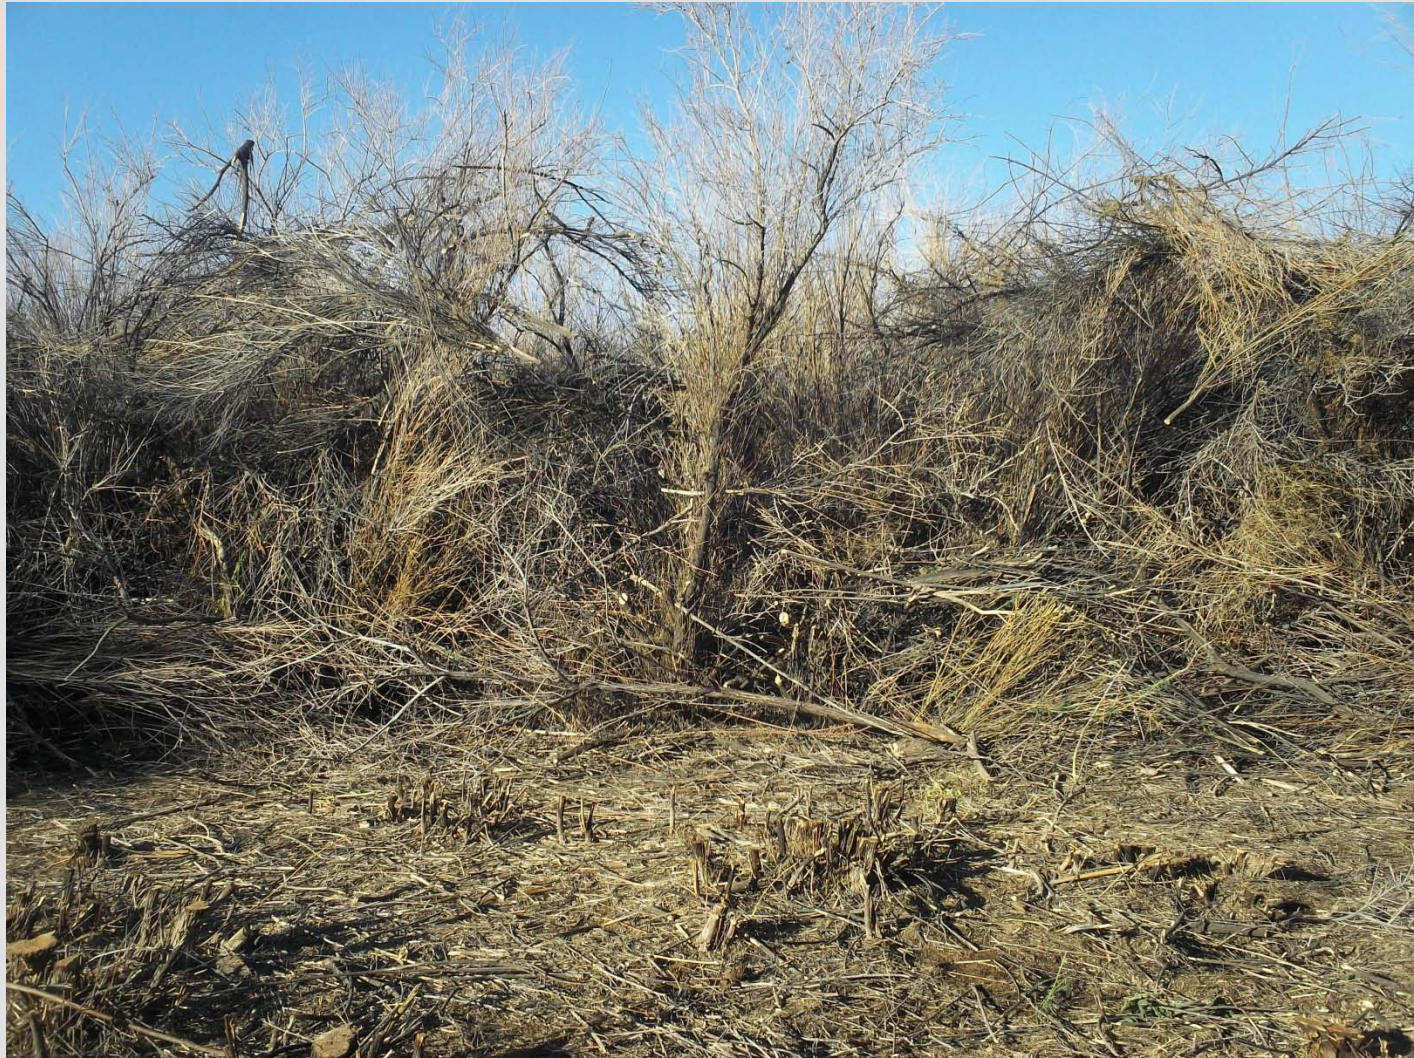
BUILD A WALL OF TAMARISK!
